**BREAKS IN PAVEMENT AND PIPES AS INDICATORS OF
RANGE-FRONT FAULTING RESULTING FROM THE 1989
LOMA PRIETA EARTHQUAKE NEAR THE SOUTHWEST MARGIN
OF THE SANTA CLARA VALLEY, CALIFORNIA**

1995

Open-File Report 95-820

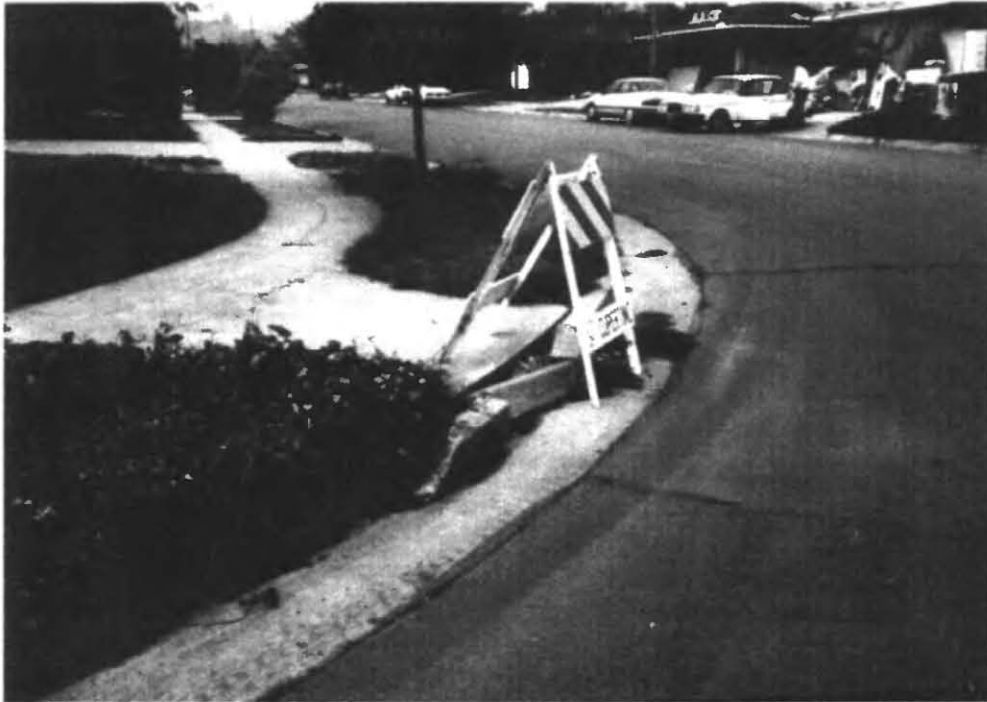
Figure 2. Contractional deformation of concrete curb at street corner in Cupertino, in Los Altos-Cupertino zone. Photograph taken February 1990 by S.D. Ellen.

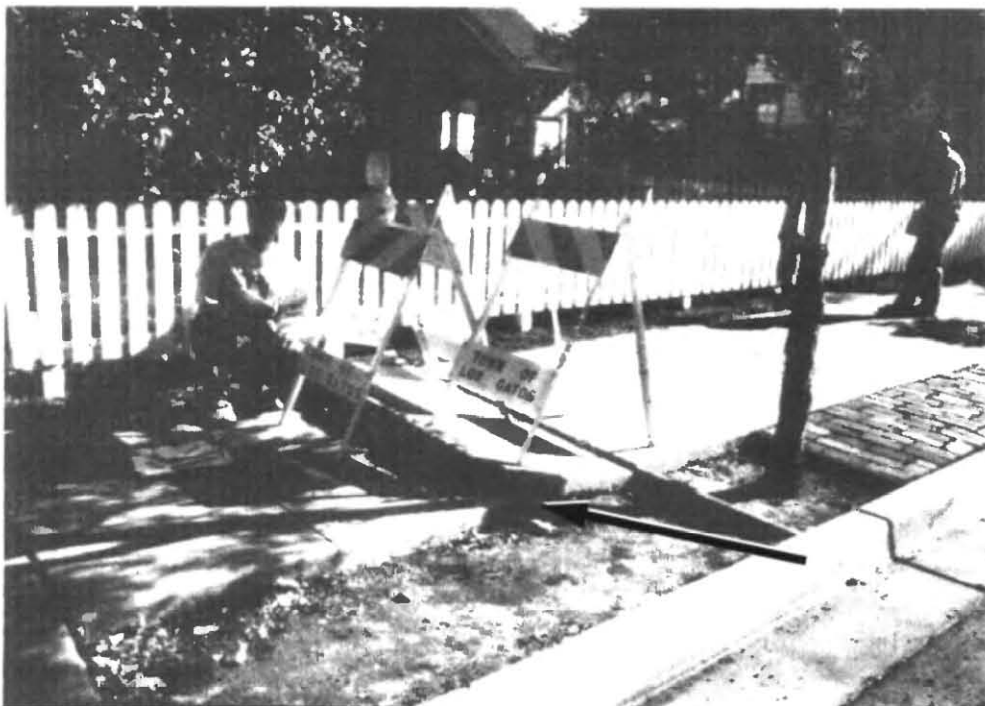
Figure 3. Thrust in NNE-trending sidewalk in Los Gatos, on University Avenue near Royce Street, looking southeast. Thrust, denoted by arrow, showed 12 cm of shortening. Adjacent curb showed no deformation. Photograph taken November 1989 by S.D. Ellen.

This category includes damage with displacements that varied from a few millimeters to 100 mm or more. Buckling and thrusting of sidewalks was prominent (fig. 3), but typically reflected shortening of only a few centimeters. Three attempts at careful measurement of sidewalk displacements along city blocks with pronounced buckling revealed little or no net shortening, because several inconspicuous extensional cracks accompanied each of the three sites (fig. 9). Because prominence of buckling did not reflect magnitude of net displacement, we ceased attempts to measure displacements associated with this damage and relied instead on geodetic and other measurements (Ellen and others, in press; Peterson and others, in press). Damage of this category was especially suggestive of faulting where concentrations were dense or where concrete was broken in close proximity on both sides of a street, suggesting a narrow, throughgoing zone of deformation.

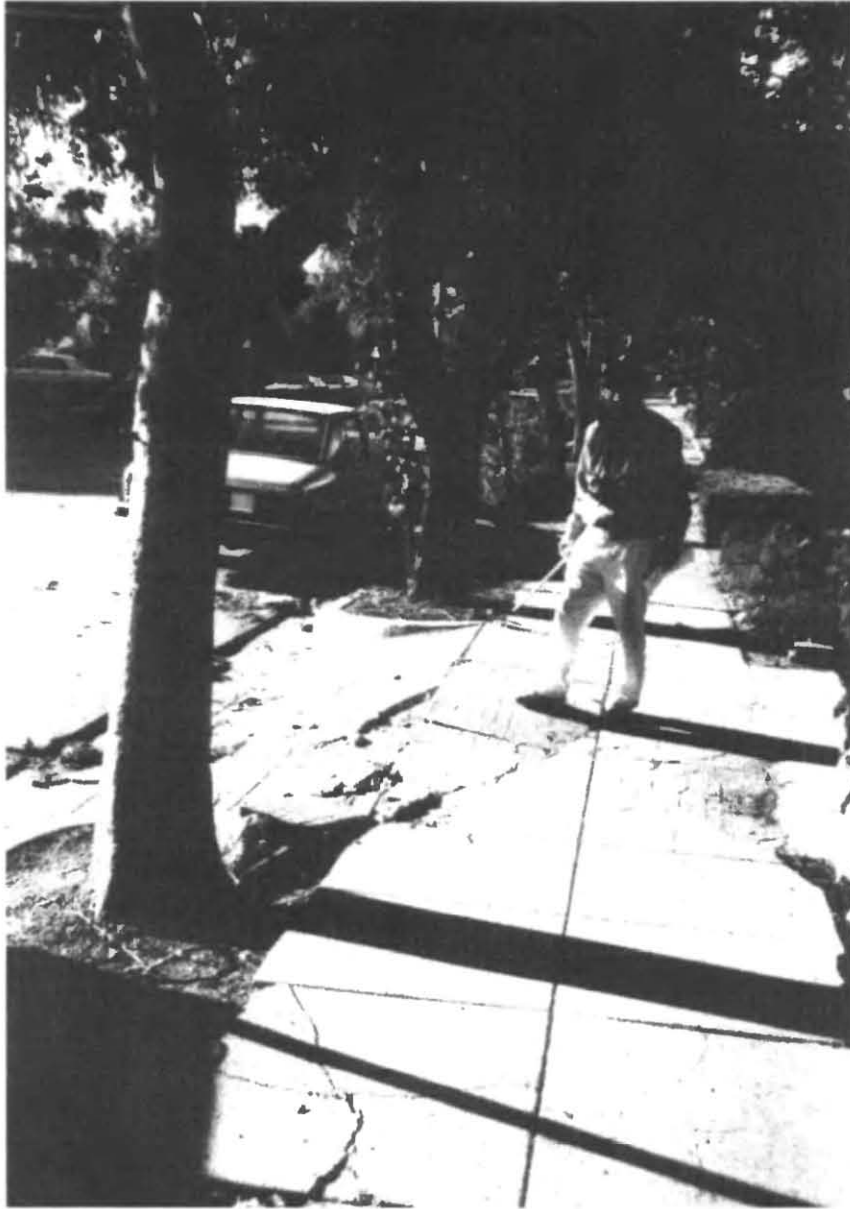
Figure 4. Buckled concrete slabs of sidewalk and driveway along WNW-trending street in Los Gatos, looking northwest. Contractional deformation along streets of this orientation was uncommon. The deformation in this photograph suggests shortening perpendicular to the street, apparently resulting from shortening along the driveway that extends across sidewalk. Photograph taken October or November 1989 by S.D. Ellen.

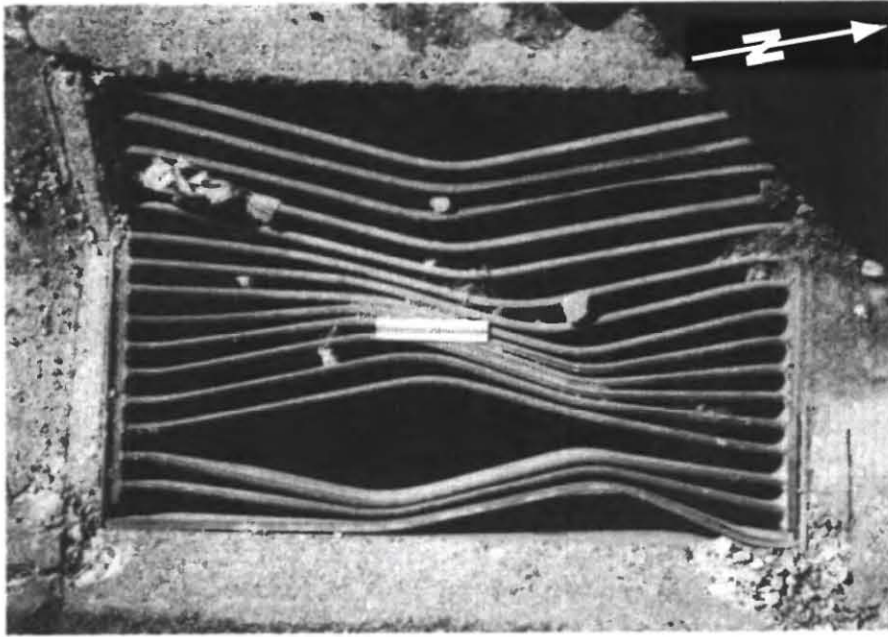
Figure 5. Storm-drain grate shortened by coseismic deformation, in onramp to southbound State Highway 17 at State Route 9 in Los Gatos. Scale in center is about 18 cm long. Note spalled concrete at corners of grate. Photograph taken late October 1989 by R.A. Haugerud.

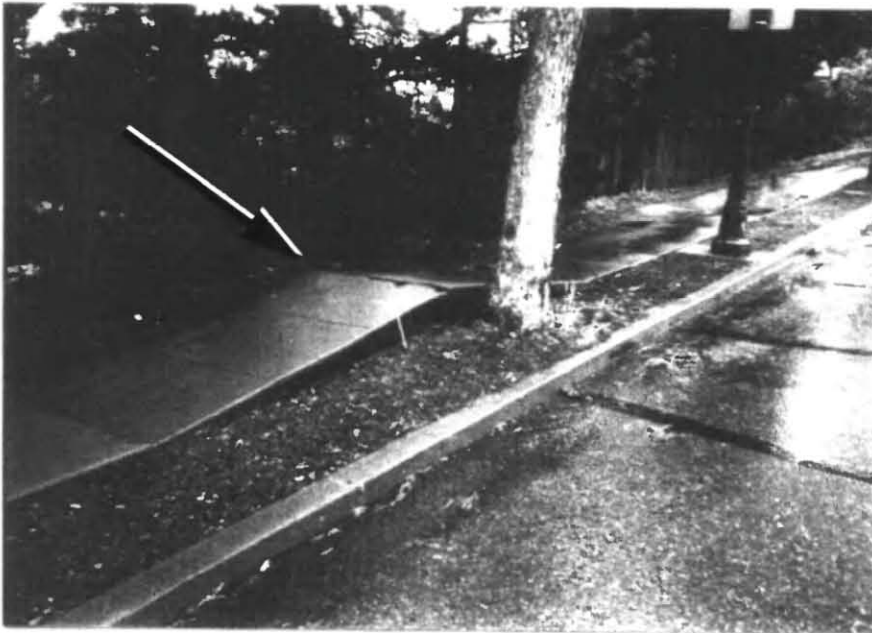
Figure 6. Buckled sidewalk, denoted by arrow, showing common occurrence at places where pre-earthquake displacement by tree roots provided initial deflection. Photograph taken late October 1989 by S.D. Ellen.

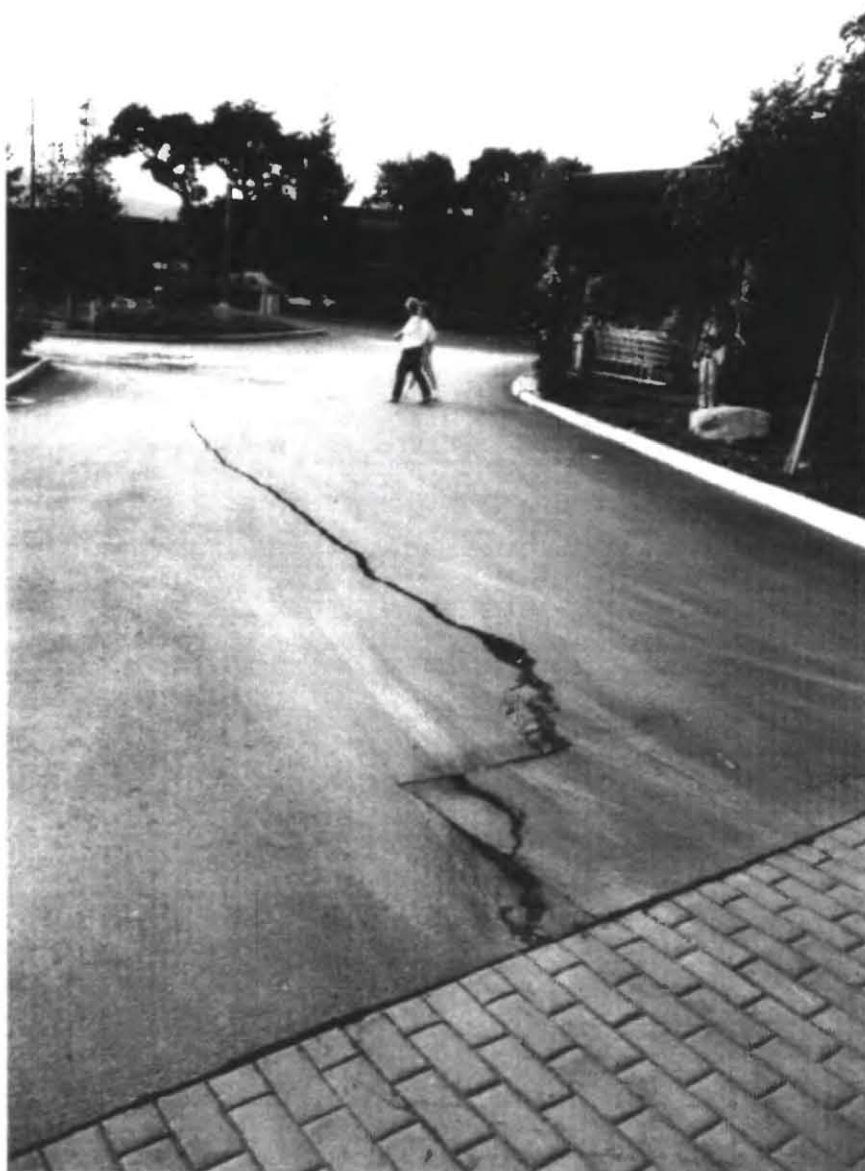
These three locations of major breakage in asphalt parking areas and playgrounds are noteworthy because of the scarcity of significant damage to asphalt. The breaks were each 30 m or more in length (fig. 7). They displayed complex cracking, the intricate details of which appeared to be controlled largely by man-made structural features of the pavement. Each of these breaks occurred near the center of a damage zone defined largely by breaks in concrete, and each trended northwest, about parallel to the trend of surrounding damage. These breaks seem to mark the hearts of the damage zones, and their occurrence there makes sense because breakage of ductile asphalt appears to have required greater or more rapid deformation than breakage of more brittle concrete or buried pipes.

Figure 7. Northwest-trending cracks in asphalt at Village Square shopping center, on Los Gatos Boulevard near Gateway Drive in Los Gatos, looking west. Photograph taken late October 1989 by S.D. Ellen.

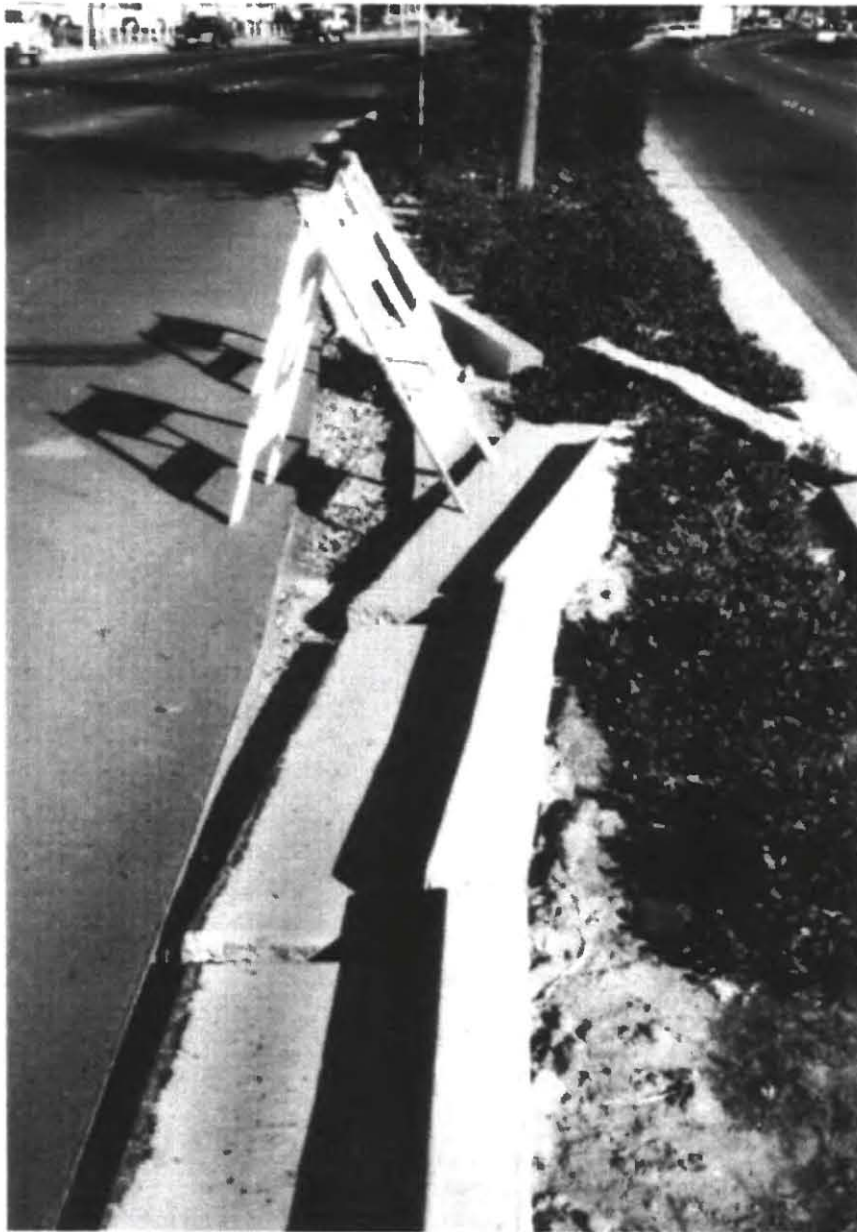
Figure 8. Contractional deformation and lateral deflection of concrete curb and gutter on Los Gatos Boulevard near the Village Square shopping center, looking northeast toward intersection with Gateway Drive. Photograph taken December 5, 1989, by J.C Tinsley, U.S. Geological Survey.

The westernmost concentration of damage in the Blossom Hill zone extended to the southeast from near Vasona Dam, through Village Square shopping center, and through a residential area along Longridge Road (plate 2). The Village Square shopping center, located on Los Gatos Boulevard south of Gateway Drive, was the site of the most severe damage recognized within the Blossom Hill zone. Damage here was expressed as complex cracks in asphalt parking areas and streets (fig. 7), and as broken sidewalks and thrust curbs that suggested northeast-southwest shortening (fig. 8).

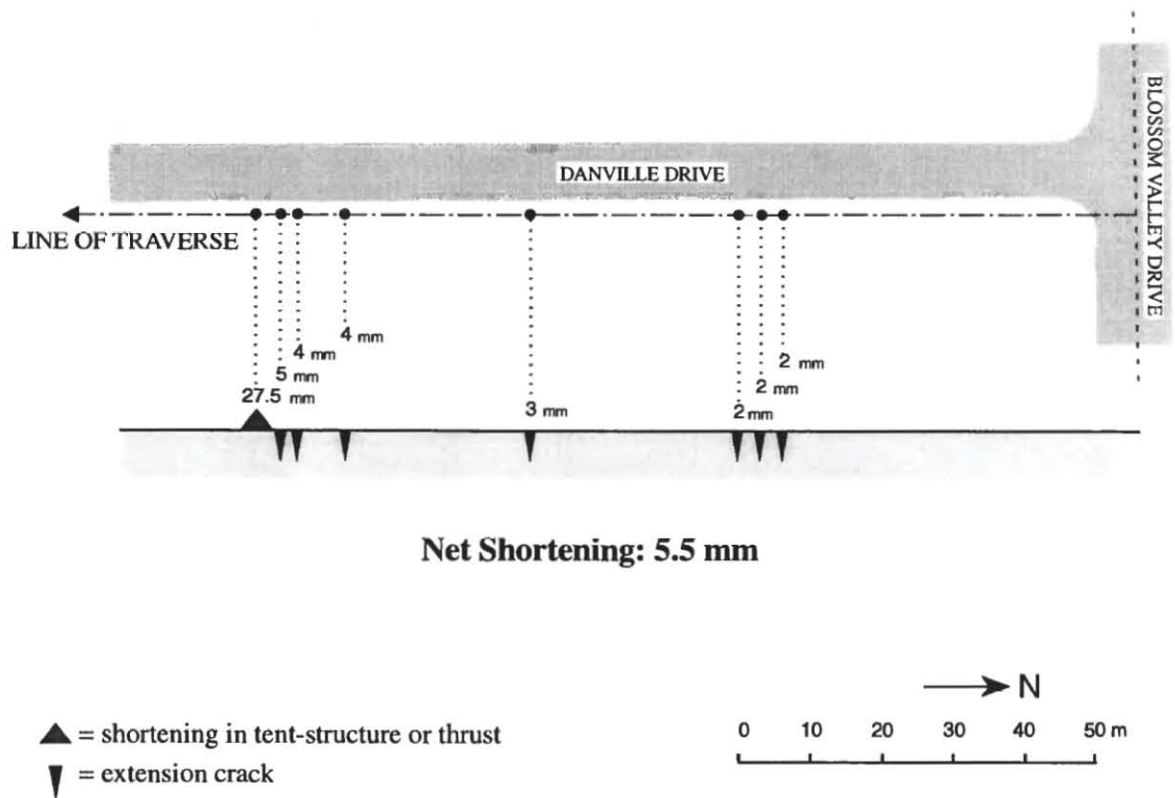
Figure 9. Schematic map and profile of measured deformation in concrete sidewalk along east side of Danville Drive in Los Gatos, showing tent structure and associated extension cracks. Extension cracks reduce the net shortening from 27.5 mm, measured at the prominent tent structure, to 5.5 mm. Measured at center of sidewalk by K. H. Chang and Mauro Cardinale, November 7, 1989.

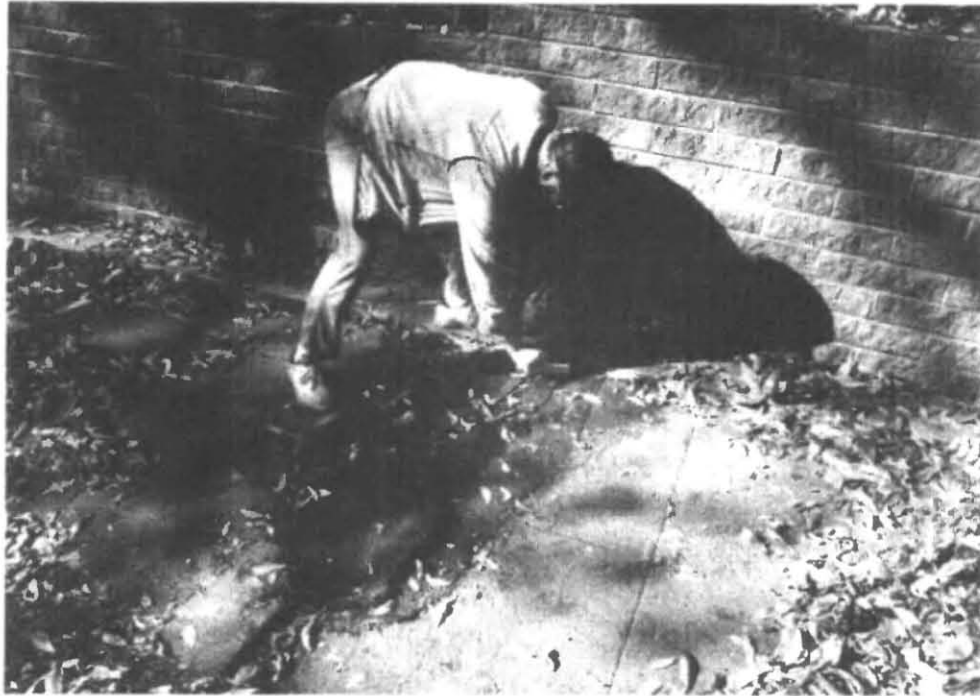
All sites of documented post-earthquake shortening in the study area occurred along the trend of concentrated damage within this zone. One site was in the sidewalk along the west side of Massol Avenue, south of the intersection with Almendra Avenue. Sidewalk slabs that buckled during the earthquake had been partly removed and repaired with an asphalt patch, which, by December 5, 1989, had shortened by about 24 mm along a thrust fracture (fig. 10). At a

Figure 10. Post-earthquake thrust in asphalt patch of sidewalk in Los Gatos, on, Massol Avenue near Almendra Avenue, looking west. The asphalt patch, which replaced concrete sidewalk damaged by the earthquake, recorded about 2.4 cm of post-earthquake shortening by, December 5, 1989, the date of this photograph. Scale in hand is about 18 cm long. Adjacent wall (background) revealed no damage. Photograph taken December 5, 1989, by S.D. Ellen.

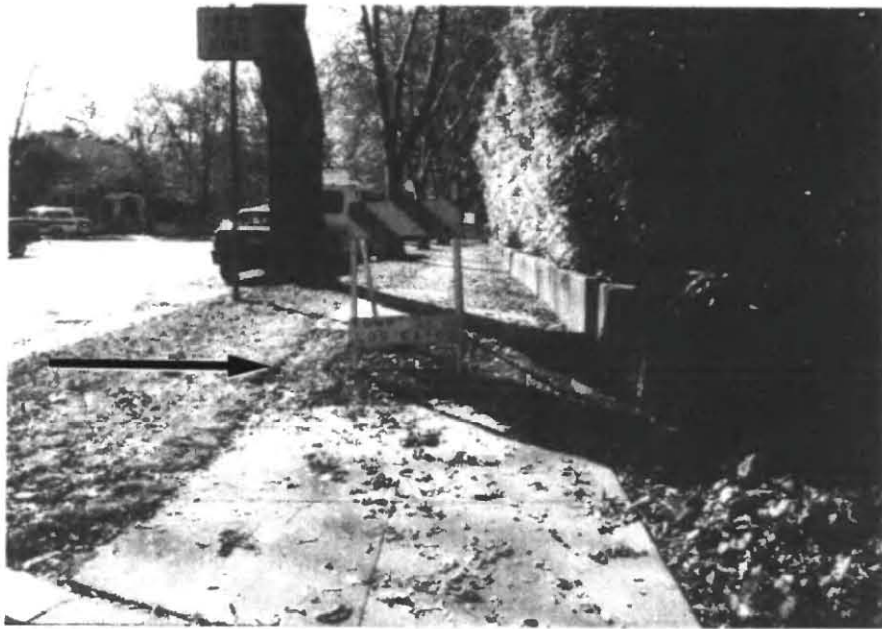
Figure 11A. Site of post-earthquake sidewalk deformation in Los Gatos, on Massol Avenue between Almendra Avenue and State Route 9. View to southwest shows asphalt patch, at site of post-earthquake thrust or tent in concrete sidewalk (denoted by arrow) that occupies abrupt step in otherwise straight stretch of sidewalk. Photograph taken December 5, 1989, by S.D. Ellen.

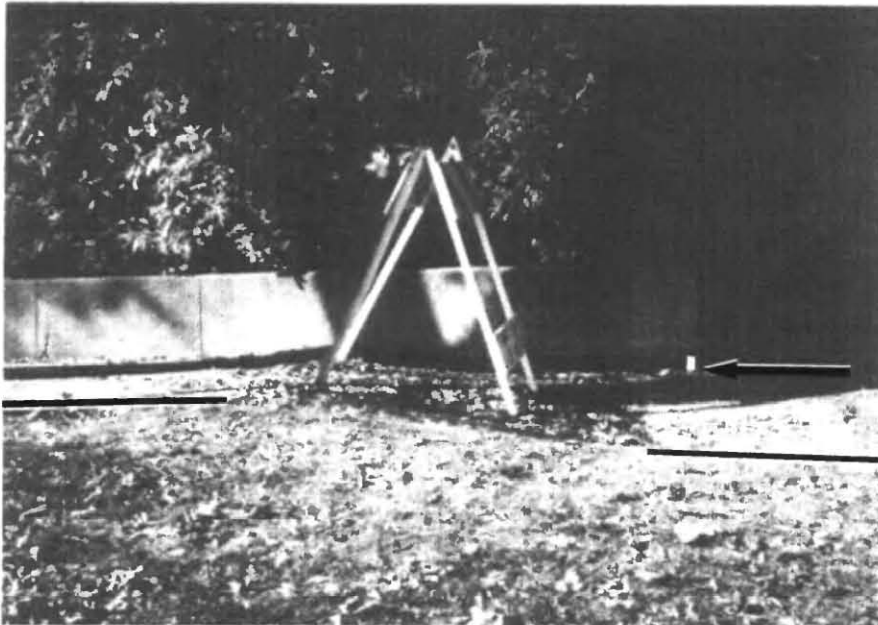
Figure 11B. Site of post-earthquake sidewalk deformation in Los Gatos, on Massol Avenue between Almendra Avenue and State Route 9. View to west reveals the relief of this step (highlighted edge of sidewalk), as well as suspended end of concrete wall (denoted by arrow) in background to right of traffic barricade. Photograph taken December 5, 1989, by J.C. Tinsley, U.S. Geological Survey.

second site, in the parking lot mentioned above, three measurements were made by steel tape across a 27-m-wide zone that included the cracking in asphalt. The measurements, taken over the period from December 7, 1989, to July 13, 1990, showed progressive shortening that totaled slightly more than 10 mm. Although the measurements were crude, we consider the shortening so detected to reflect real ground deformation because 1) the measured shortening is far greater than the potential thermal contraction of the measuring tape, and 2) measurements of similar length at another site during the same period remained constant within ± 1.0 mm. At two other locations along this trend of concentrated damage, concrete pavement deformed noticeably during the period between a day and a month after the earthquake, according to a U.S. Postal Service employee who walked the sidewalk daily to deliver mail (A. Morrisette, oral commun., 1989; fig. 11).

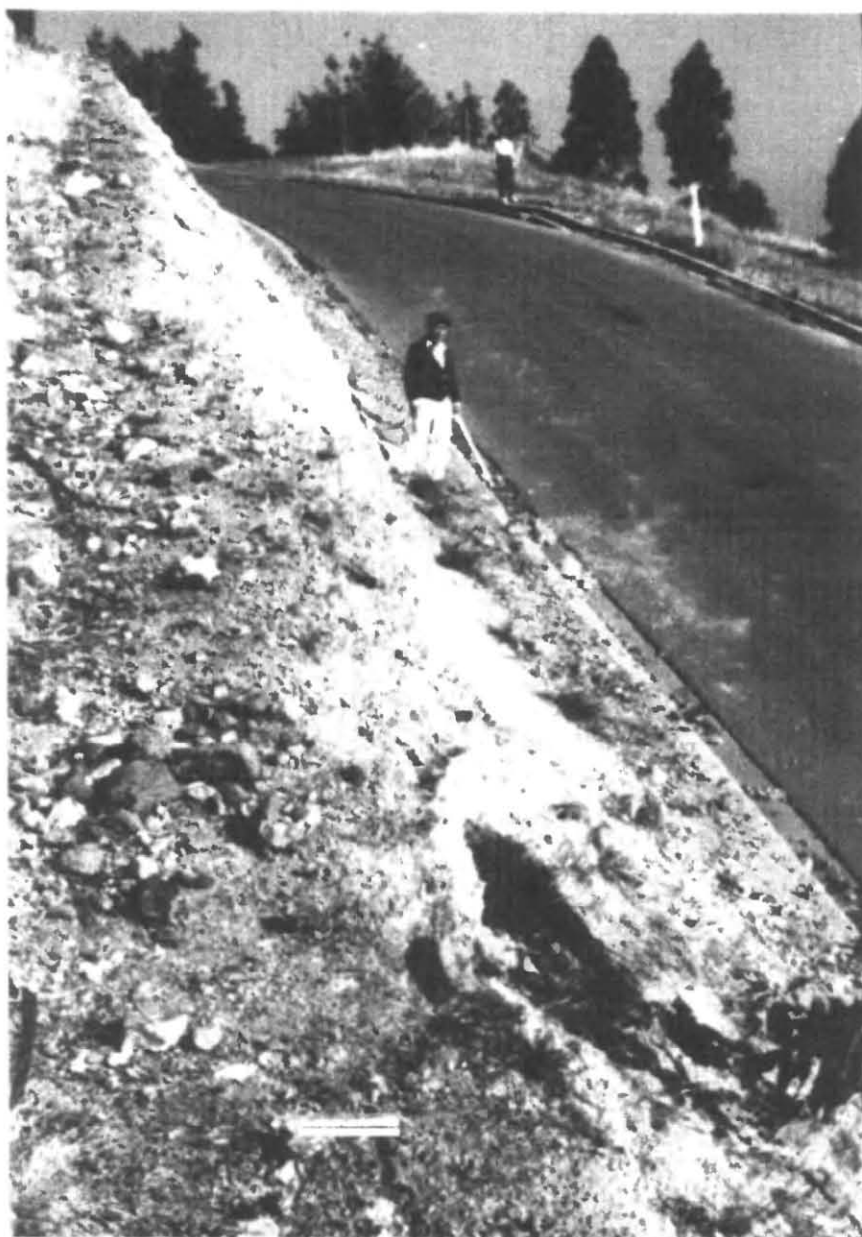
Figure 12A. Coscismic breaks along fault contact in Los Gatos, at Top of the Hill Road near Kennedy Road. View to east along alignment of breaks, from crack in bench of cut slope (foreground, at 18-cm-long highlighted ruler) to breaks in curbs near people in midground and background. Asphalt between broken curbs shows only minor cracks. Photograph taken November 4, 1989, by S.D. Ellen.

of the Hill Road were deformed (figs. 12 A, B). Buckling of the easternmost curb indicated 40-60 mm of shortening along the trend of the curb. The asphalt road surface between the curbs showed minimal deformation.

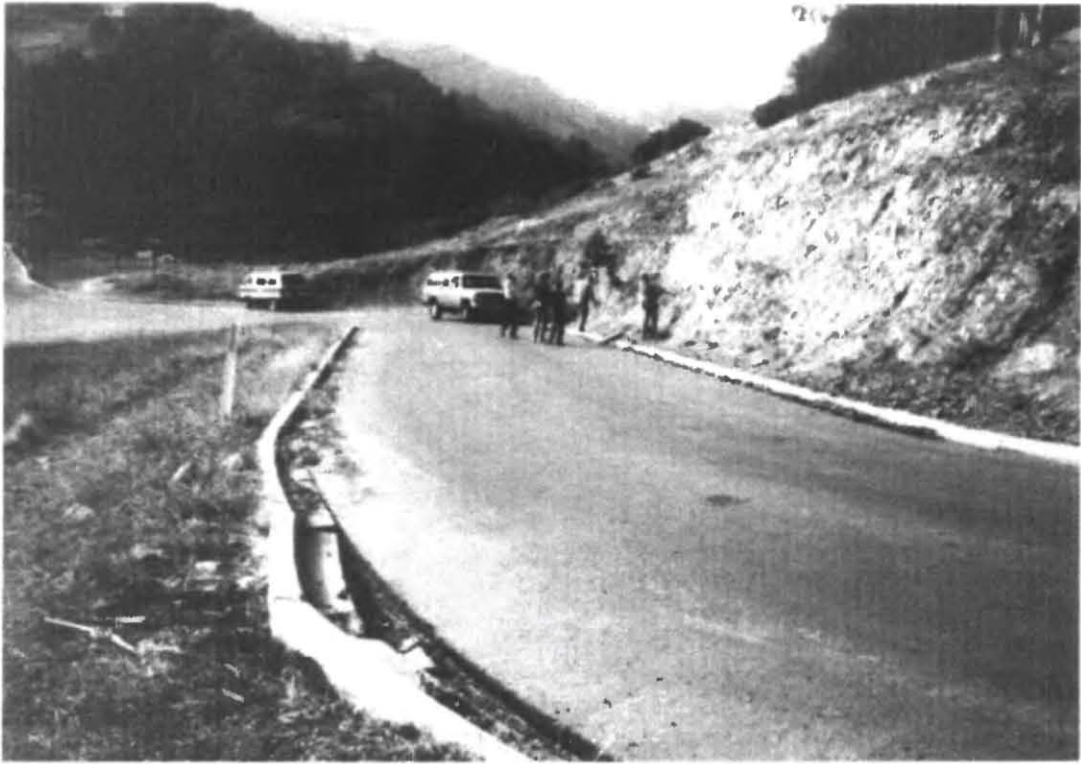
Figure 12B. Coseismic breaks along fault contact in Los Gatos, at Top of the Hill Road near Kennedy Road. View to west, opposite to view in (A), showing buckled curb shown in background of (A). Measurement of deformation indicates shortening of about 4 - 6 cm along the trend of the curb. The fault contact exposed in roadcut near people in the background separates sedimentary rocks (behind parked vehicles to left) from serpentinite (light colored rock at right). Fractures in rocks along contact showed fresh openings resulting from coseismic movement. Photograph taken December 5, 1989, by J.C. Tinsley, U. S. Geological Survey.
